Hydrology Memorandum

Water Resources Technical Memorandum

To: Idaho Panhandle National Forests and Lolo National Forest
From: Chris Garrett, SWCA Environmental Consultants
Date: November 6, 2015
Subject: Analysis of Environmental Consequences for Water Resources, Lookout Pass Ski Area Expansion Draft Environmental Impact Statement

Field Photographs (June 23–24, 2015)

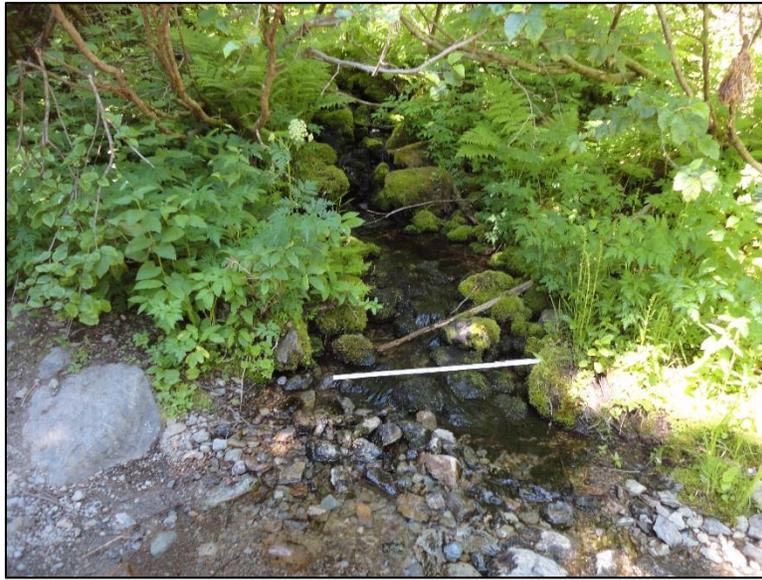
1. Unmapped tributary to St. Regis River (Map ID SR2)	47.44433	-115.714	Boulders, bedrock	3	0.3	10	0.238	4	1.3	A1	583 (Upstream) 584 (Downstream)
9. St. Regis River near SR2 confluence	47.44352	-115.714	Cobbles	16	0.4 (average of 9 measurements)	40	0.037	50	3.1	B3	597 (Upstream) 598 (Downstream)

Photograph 583. Field point 1, tributary SR2, looking downstream.

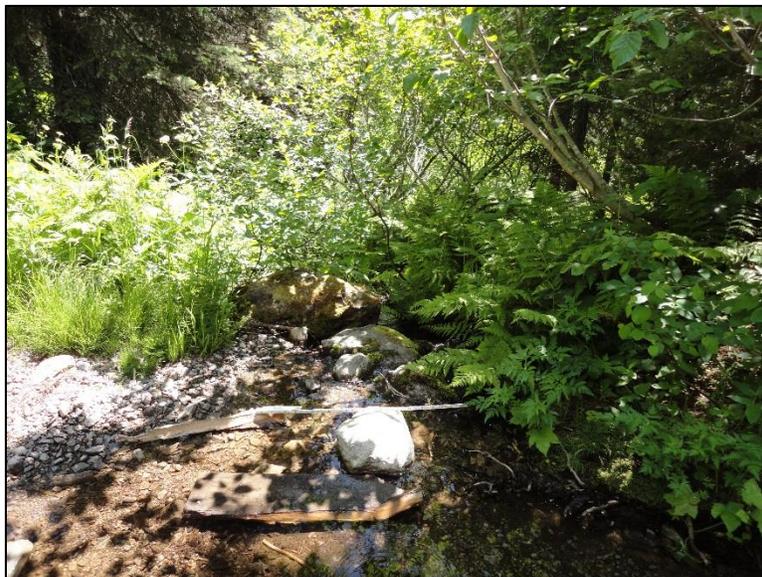
Photograph 584. Field point 1, tributary SR2, looking upstream.

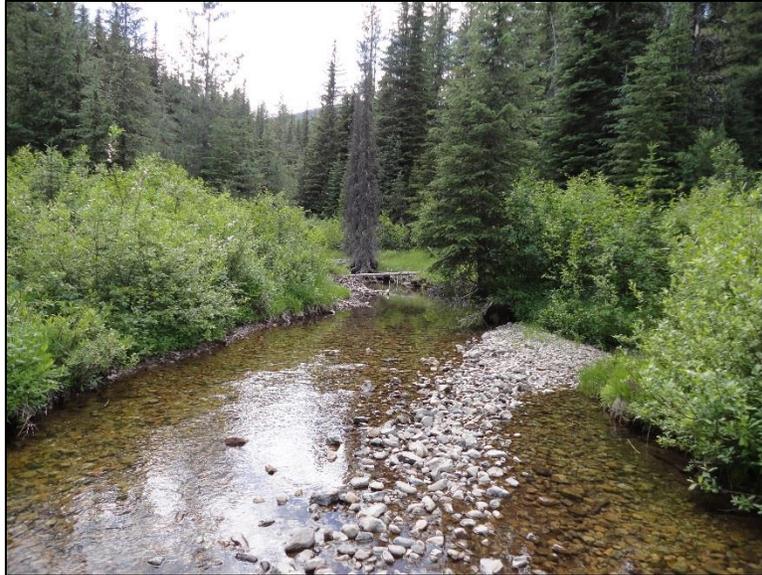
Photograph 597. Field point 9, St. Regis River near tributary SR2, looking upstream.

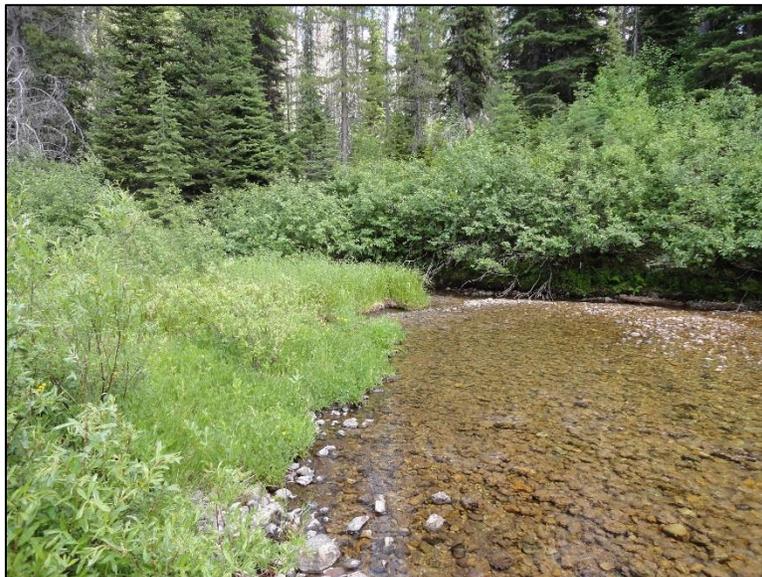
Photograph 598. Field point 9, St. Regis River near tributary SR2, looking downstream.

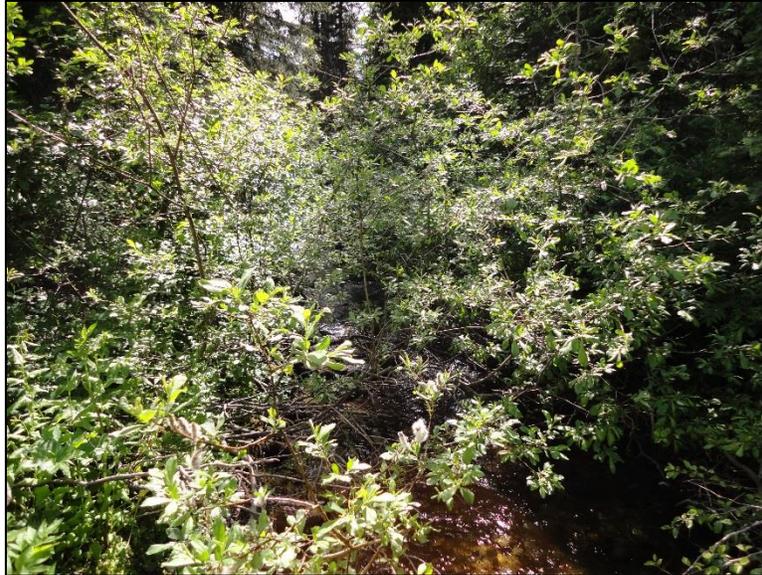
10. St. Regis River near old rail crossing	47.444	-115.708	Cobbles	10	0.8 (average of 2 measurements)	10	0.057	30	3.0	A3	600 (Upstream) 599 (Downstream and of Culvert)

Photograph 600. Field point 10, St. Regis River at old rail crossing, looking upstream.

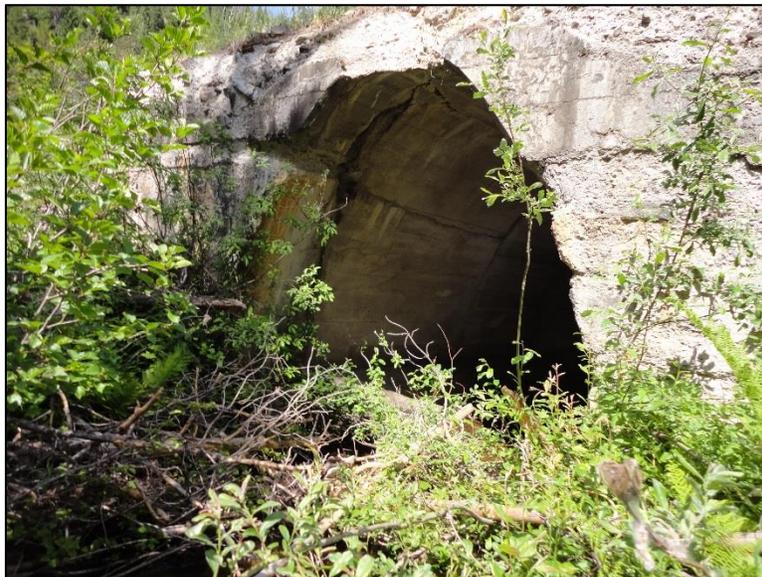
Photograph 599. Field point 10, St. Regis River at old rail crossing, looking downstream with culvert.

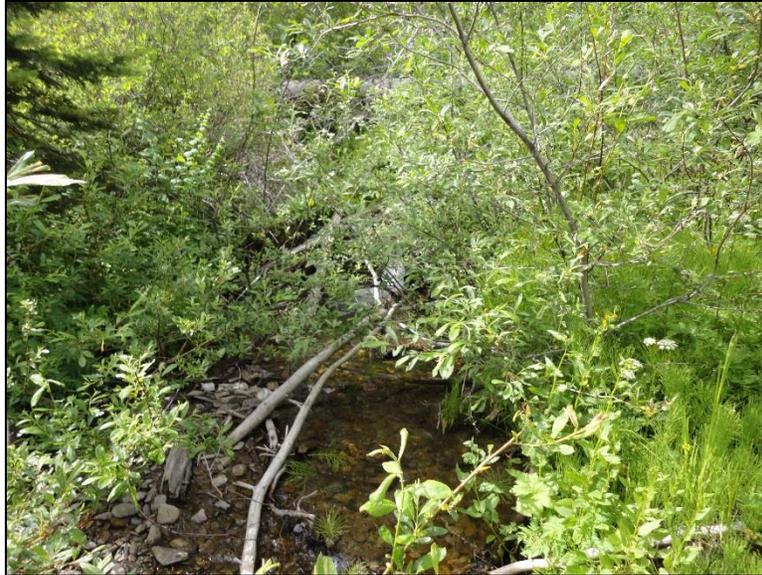
11. Tributary adjacent to interstate (Map ID SR3) near confluence	47.44456	-115.694	Cobbles	6	0.4 (average of 3 measurements)	15	0.169	8	1.3	A3	602 (Upstream) 601 (Downstream and of Culvert)

Photograph 602. Field point 11, tributary SR3, looking upstream.

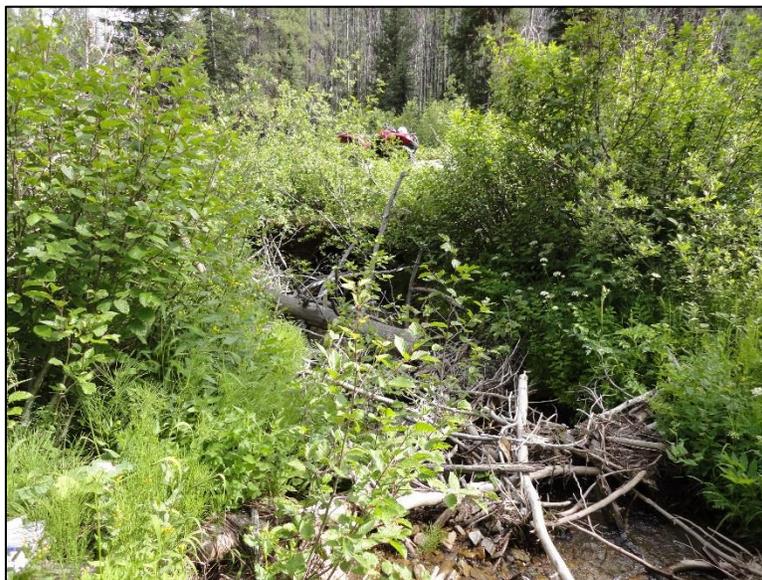
Photograph 601. Field point 11, tributary SR3 with culvert, looking downstream.

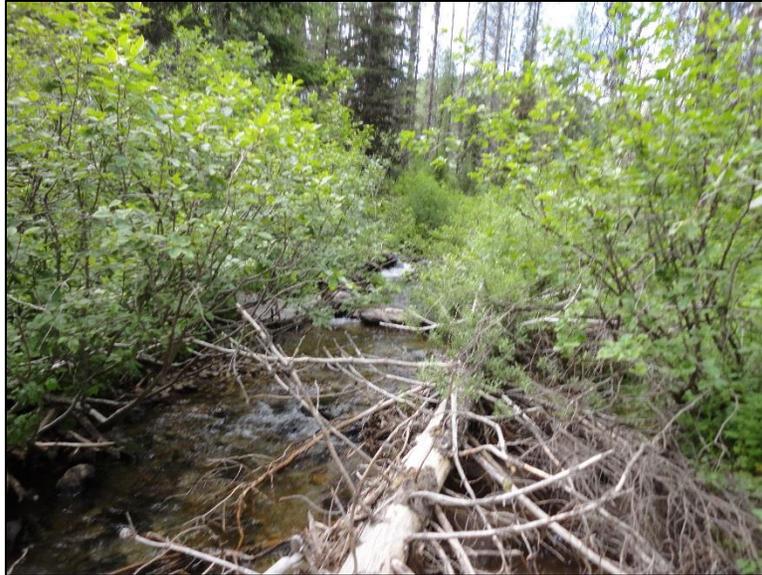
12. St. Regis River below SR3 confluence	47.44368	-115.693	Boulders, bedrock	12	0.6 (average of 3 measurements)	20	0.055	24	2.0	A1	603 (Upstream) 604 (Downstream)

Photograph 603. Field point 12, St. Regis River below tributary SR3, looking upstream.

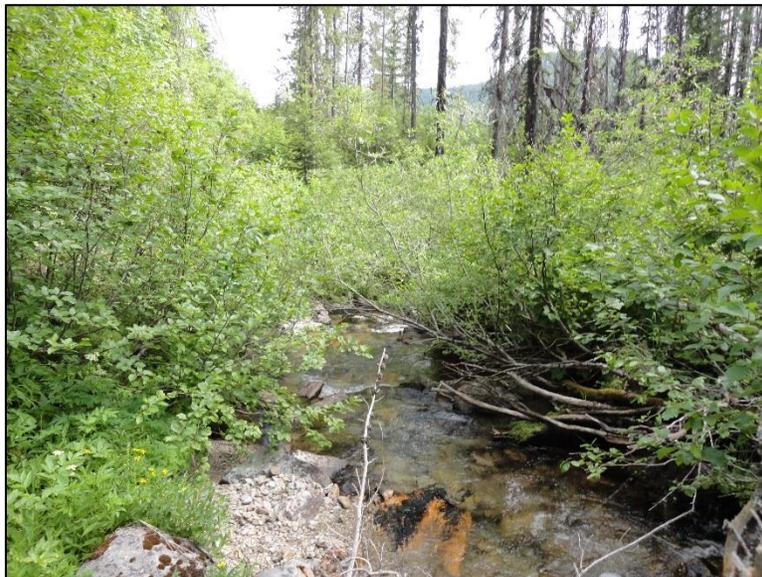
Photograph 604. Field point 12, St. Regis River below tributary SR3, looking downstream.

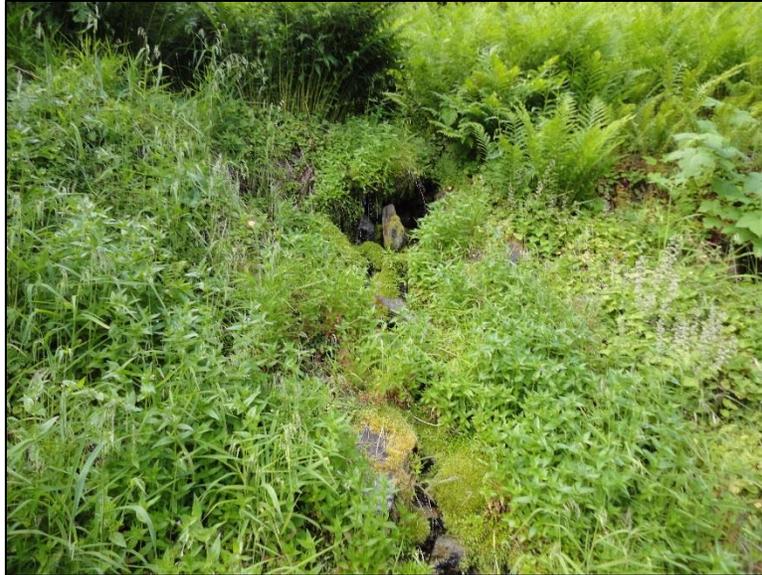
17. Unmapped spring runoff from existing ski slope (Map ID CA4)	47.45987	-115.711			Flows directly into culvert, no measurements feasible						613 (Upstream) 614 (Downstream and of Culvert)

Photograph 613. Field point 17, unmapped spring runoff from existing ski slope (CA4), looking upstream at discharge point.

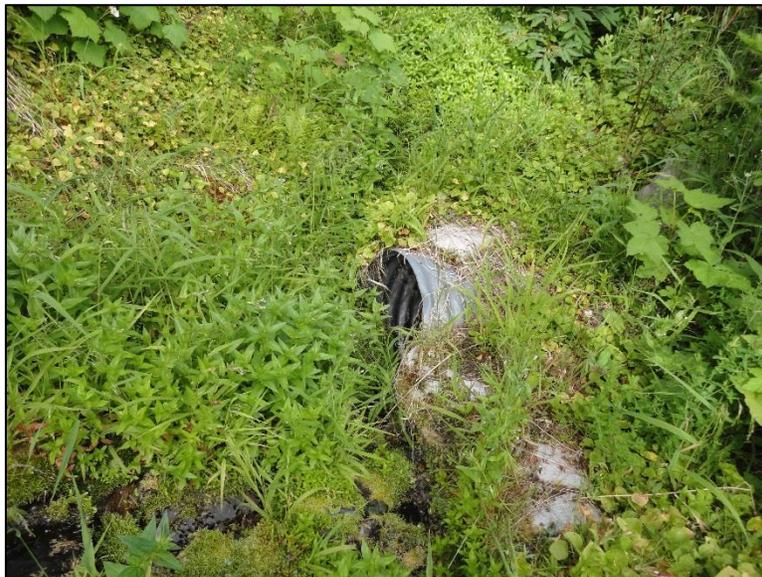
Photograph 614. Field point 17, unmapped spring runoff from existing ski slope (CA4), looking downstream at culvert exit.

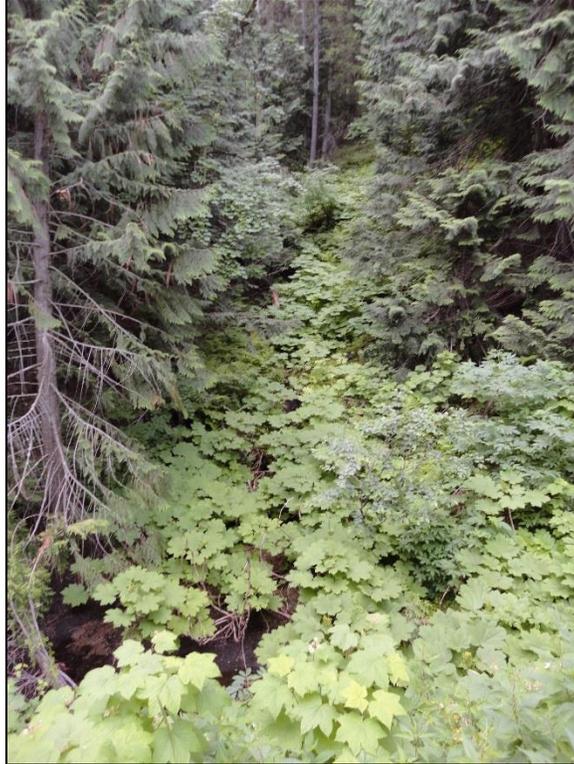
19. Tributary on north slope (Map ID CA3, east branch)	47.45845	-115.717	Boulders, bedrock	~2 (channel not visible under vegetation)	~0.1	20	0.667	~2.5	~1.3	A1	617 (Upstream)

Photograph 617. Field point 19, tributary CA3 (east branch), looking upstream.

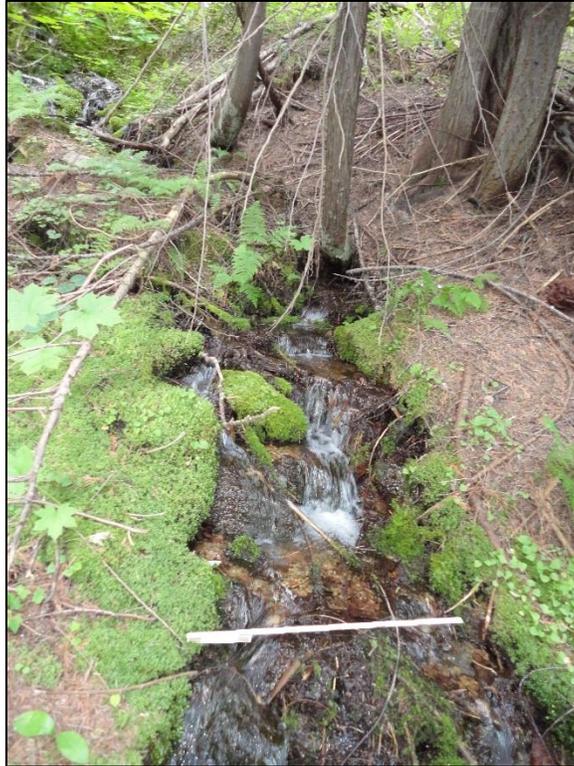
20. Tributary on north slope (Map ID CA3, west branch)	47.45804	-115.72	Bedrock	3	0.3 (average of 3 measurements)	10	0.571	4	1.3	A1	619 (Upstream) 618 (Downstream and of Culvert)

Photograph 619. Field point 20, tributary CA3 (west branch), looking upstream.

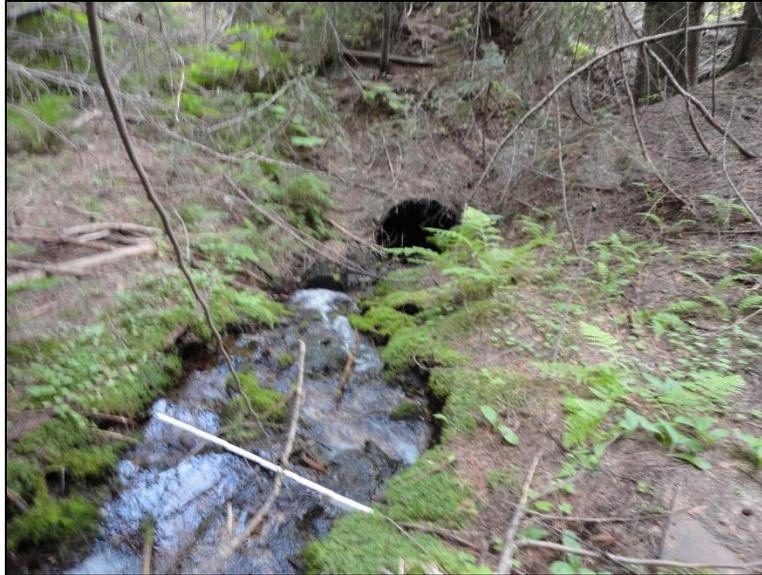
Photograph 618. Field point 20, tributary CA3 (west branch), looking downstream with culvert.

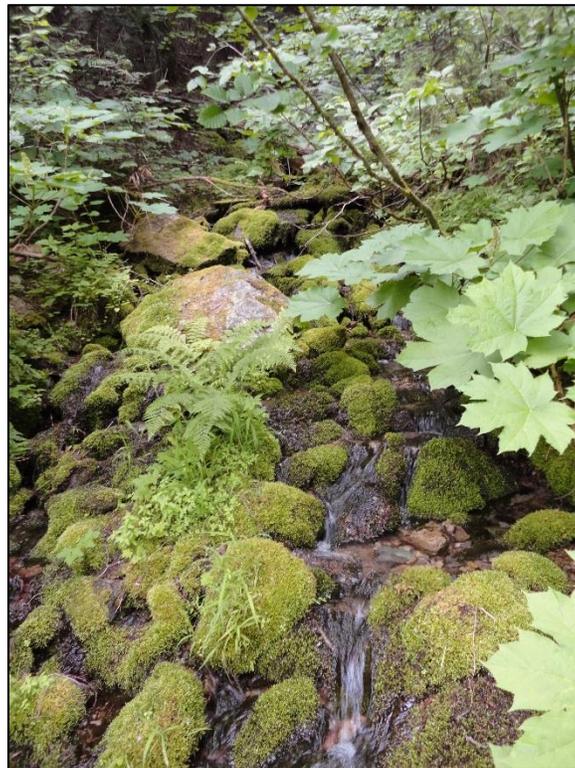
21. Tributary on north slope (Map ID CA2), at toe of slope	47.45584	-115.729	Boulders, bedrock	4	0.3 (average of 4 measurements)	13	0.454	5	1.3	A1	621 (Upstream) 620 (Downstream and of Culvert)

Photograph 621. Field point 21, tributary CA2 (toe of slope), looking upstream.

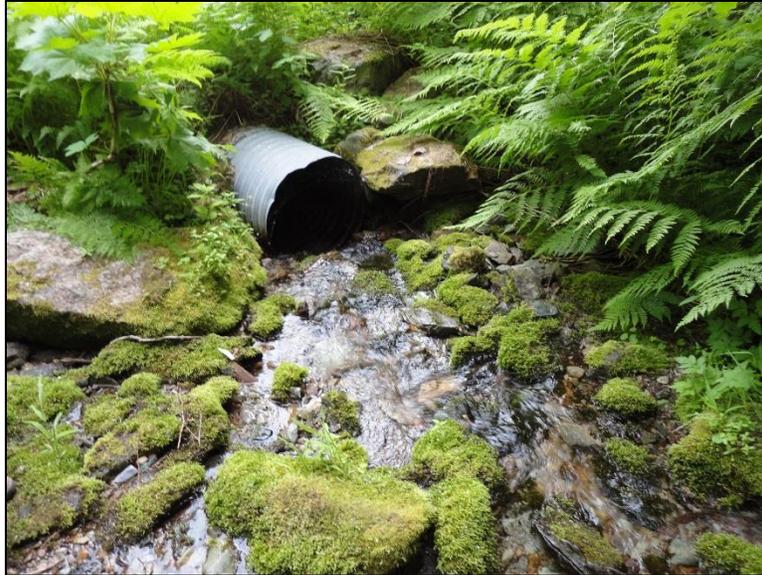
Photograph 620. Field point 21, tributary CA2 (toe of slope), looking downstream with culvert.

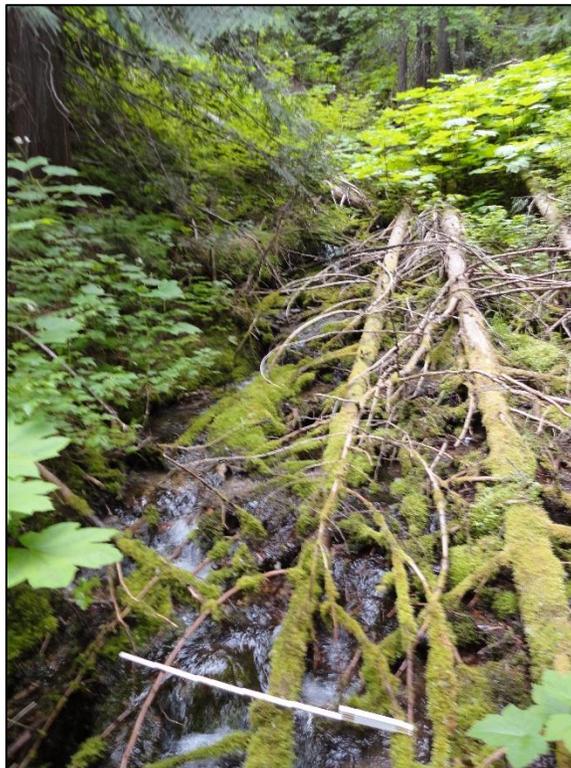
22. Tributary on north slope (Map ID CA1), at toe of slope	47.45801	-115.737	Boulders, bedrock	10	0.4 (average of 4 measurements)	25	0.268	12	1.2	A1	624 (Upstream) 623 (Downstream and of Culvert)

Photograph 624. Field point 22, tributary CA1 (toe of slope), looking upstream.

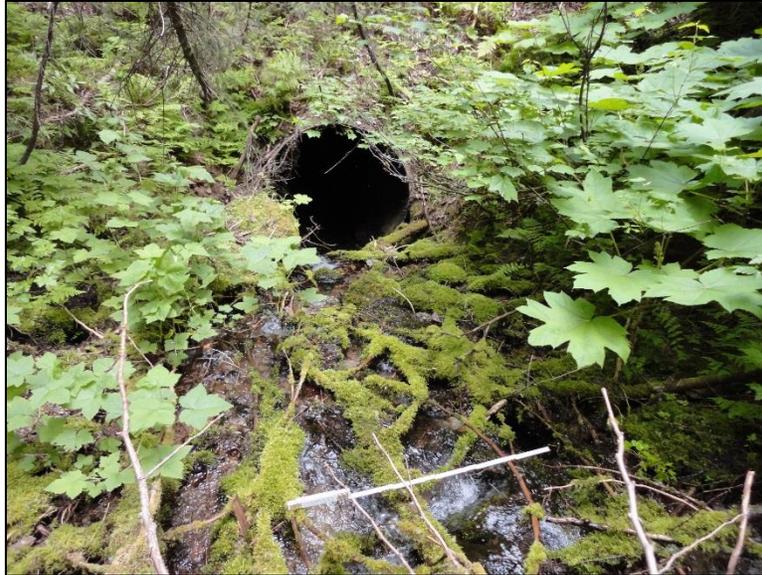
Photograph 623. Field point 22, tributary CA1 (toe of slope), looking downstream with culvert.

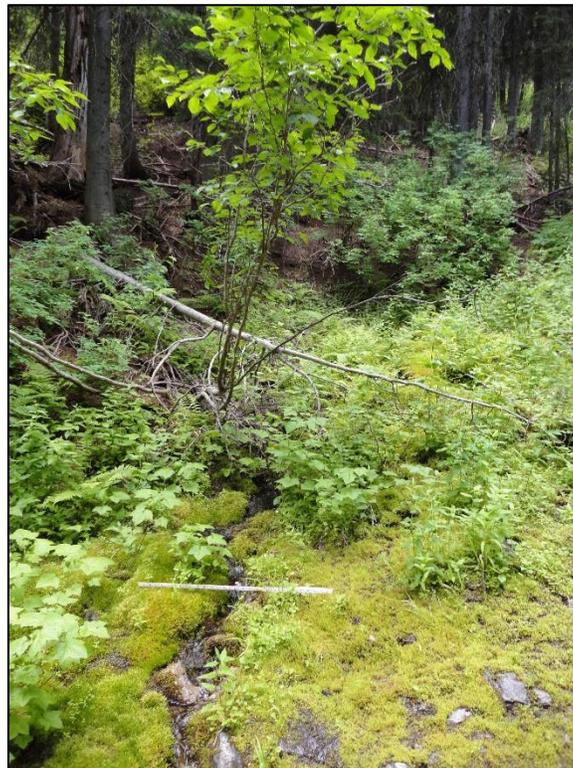
29. Tributary on north slope (Map ID CA1), at top of slope (four different stream braids)	47.44812	-115.74	Boulders, bedrock	0.8	0.1 (single measurement)	8	0.482	1	1.3	A1	641 (Upstream) 642 (Downstream)

Photograph 641. Field point 29, tributary CA1 (top of slope), looking upstream.

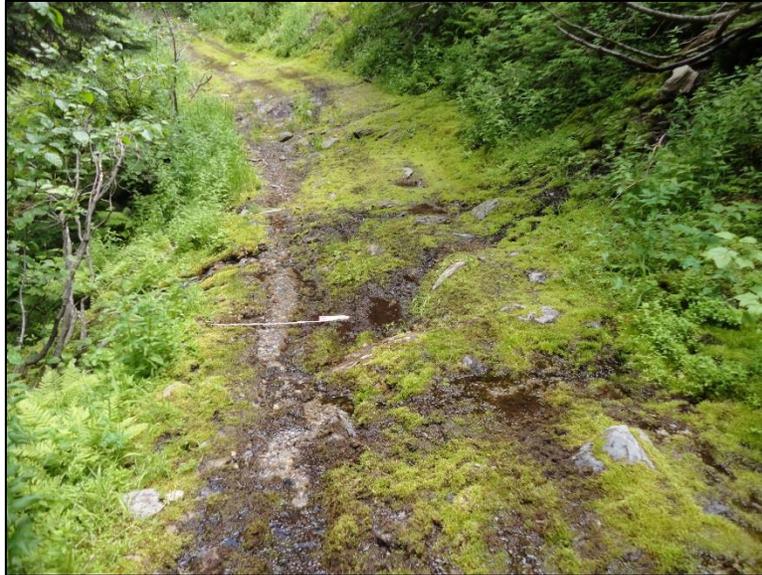
Photograph 642. Field point 29, tributary CA1 (top of slope), looking downstream at flow along roadway.

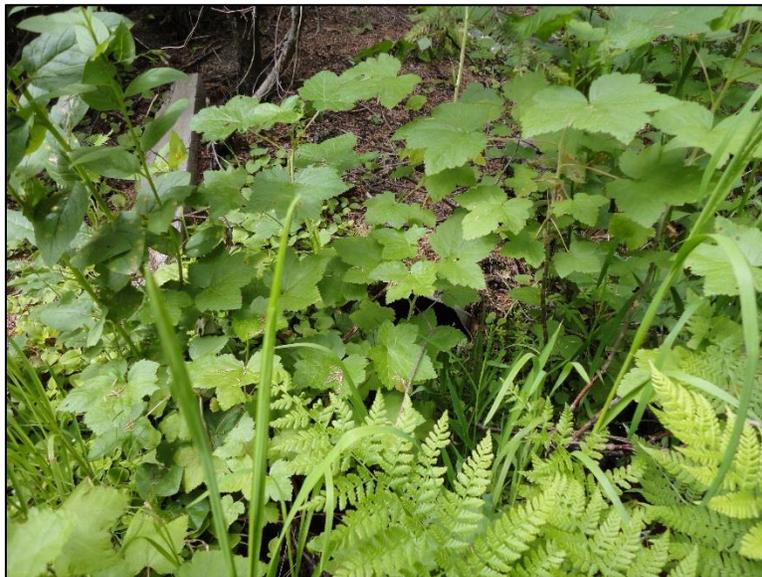
31. Tributary adjacent to interstate (Map ID SR3) at headwaters	47.45296	-115.695	Boulders, bedrock	0.8	0.1 (single measurement)	5	0.095	1	1.3	A1	649 (Culvert)

Photograph 649. Field point 31, headwaters of tributary SR3, looking at culvert discharge (source unknown).
